WL-TM-91-307-FIBG

ADD-ON DAMPING TREATMENT FOR LIFE
EXTENSION OF THE F-15 UPPER-OUTER
WING SKIN

ACOUSTICS AND SONIC FATIGUE GROUP
STRUCTURAL DYNAMICS BRANCH

30 SEPTEMBER 1991

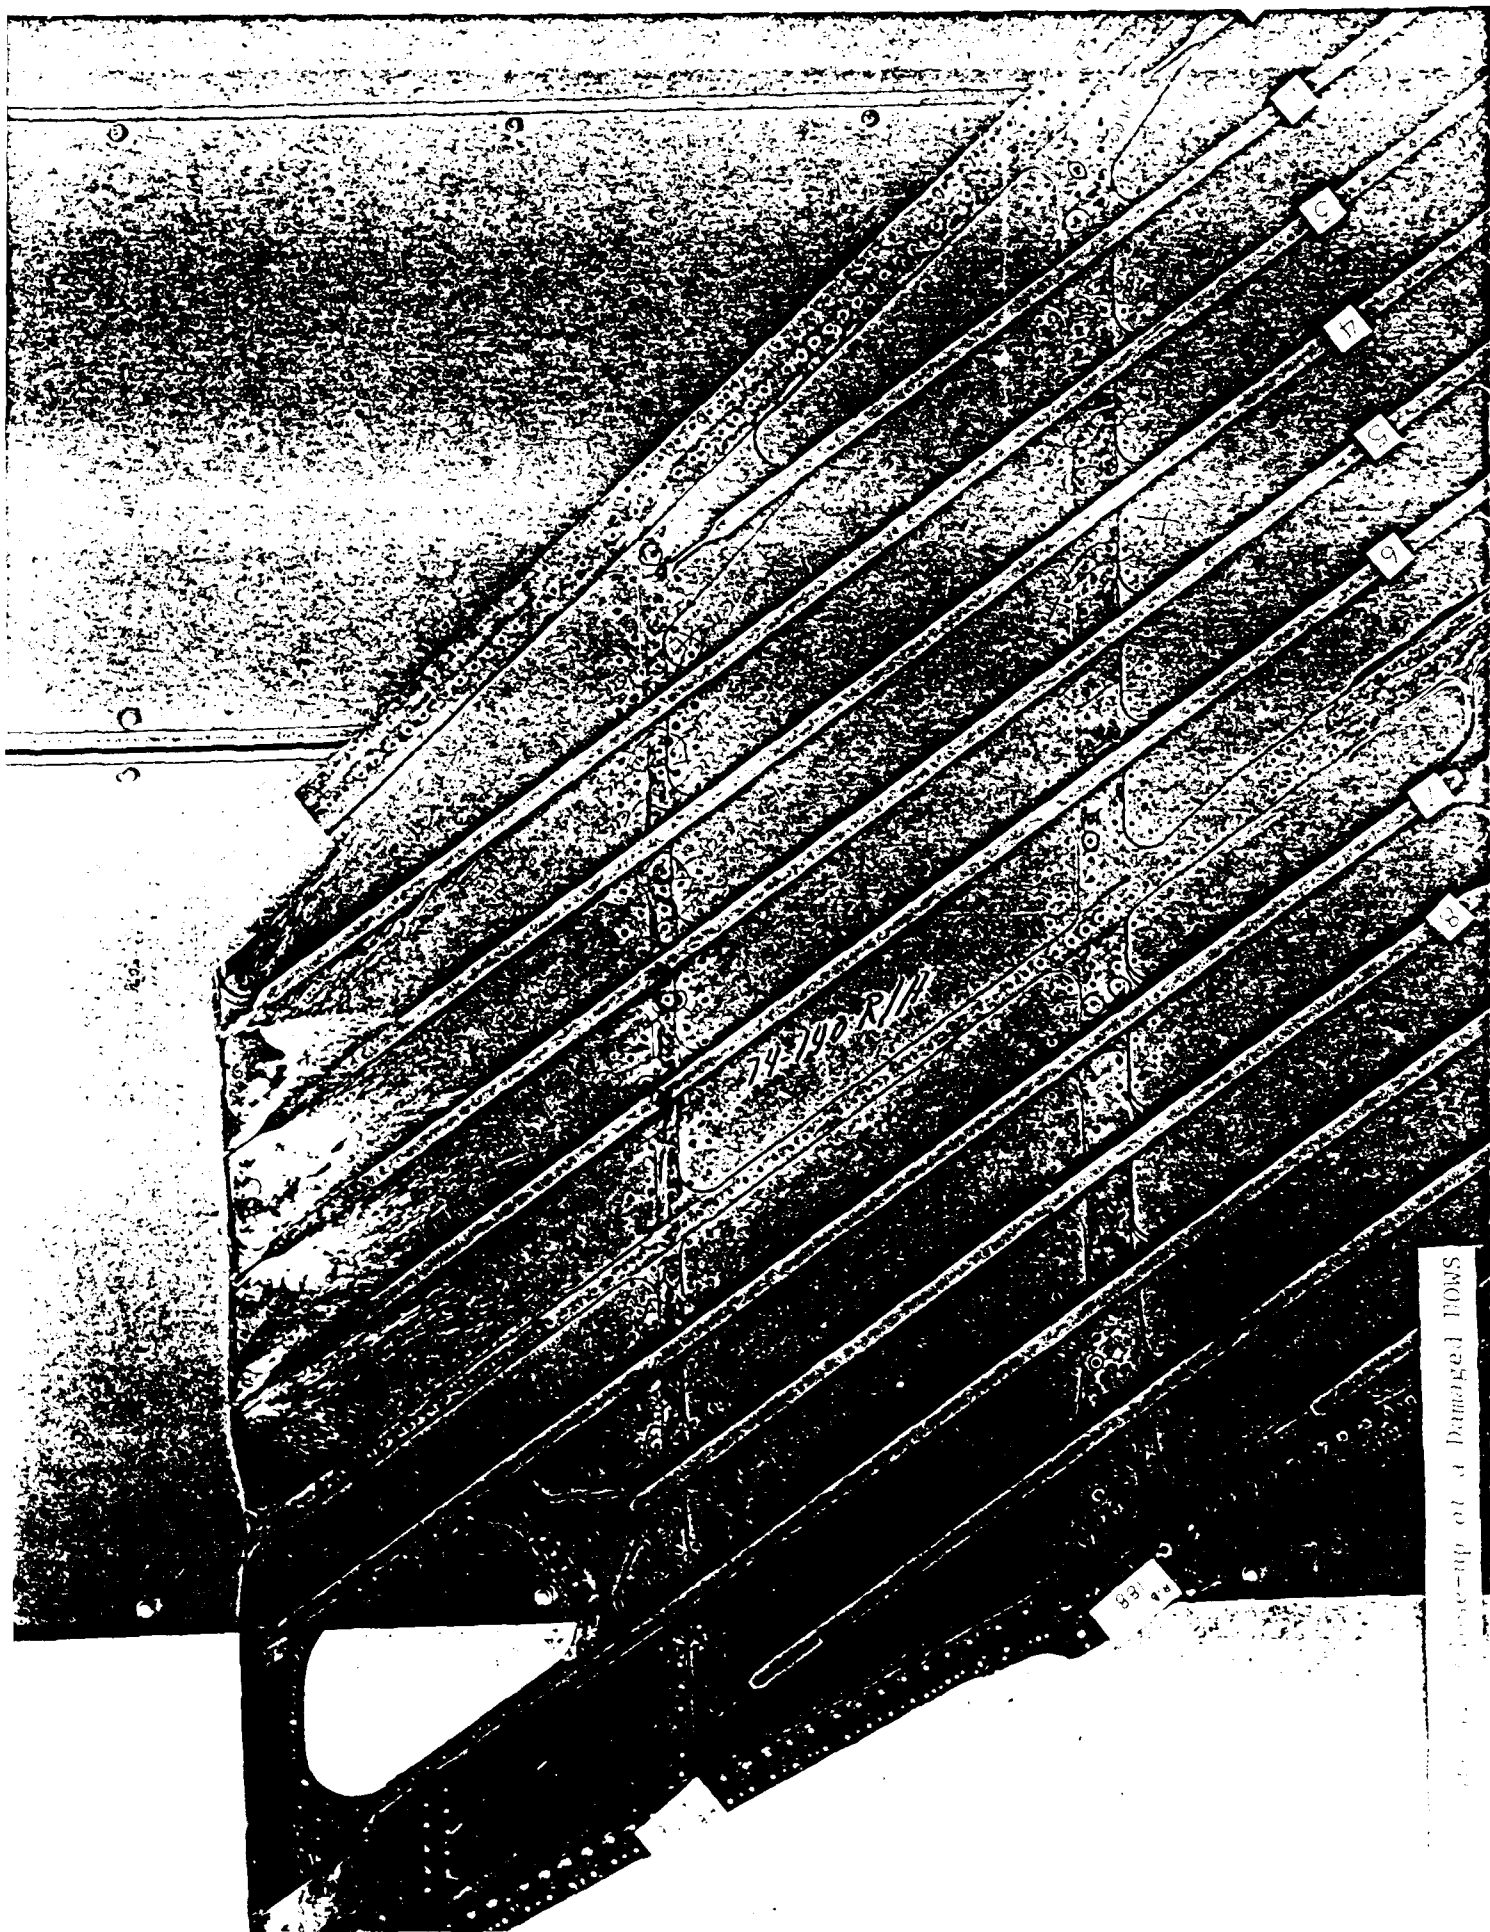
Close-up of a Damaged FOWS

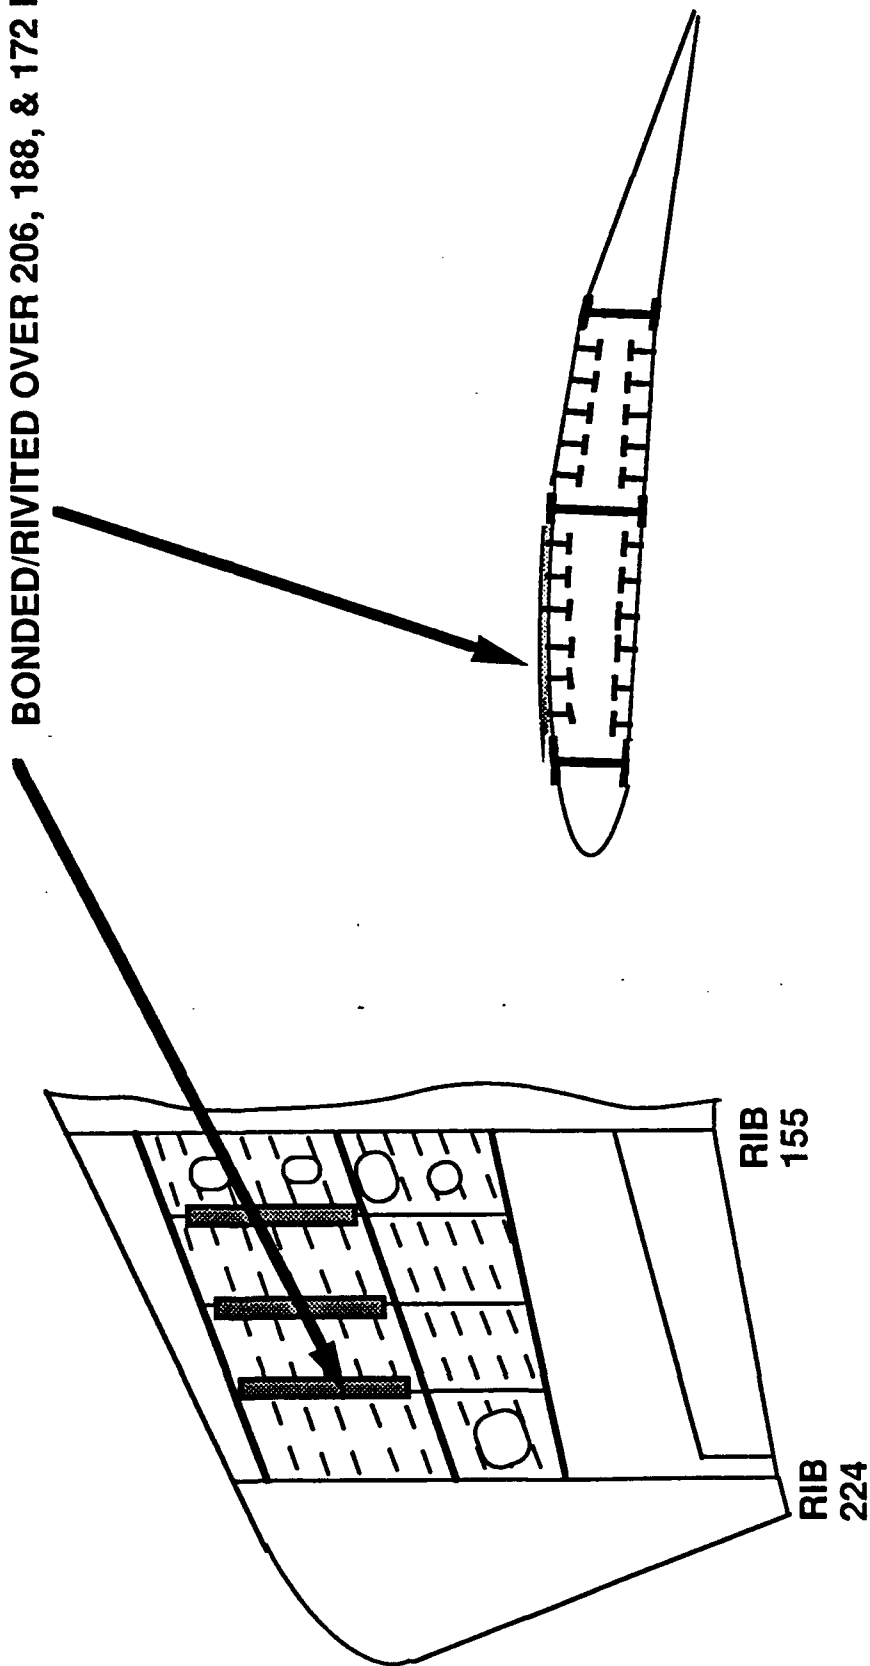
Figure 5. Detail of External Straps

FIELD INSTALLED STAINLESS STEEL STRAPS TO EXTEND SERVICE LIFE

5 INCH WIDE BY 1/8 INCH THICK STRAPS
BONDED/RIVETED OVER 206, 188, & 172 RIBS

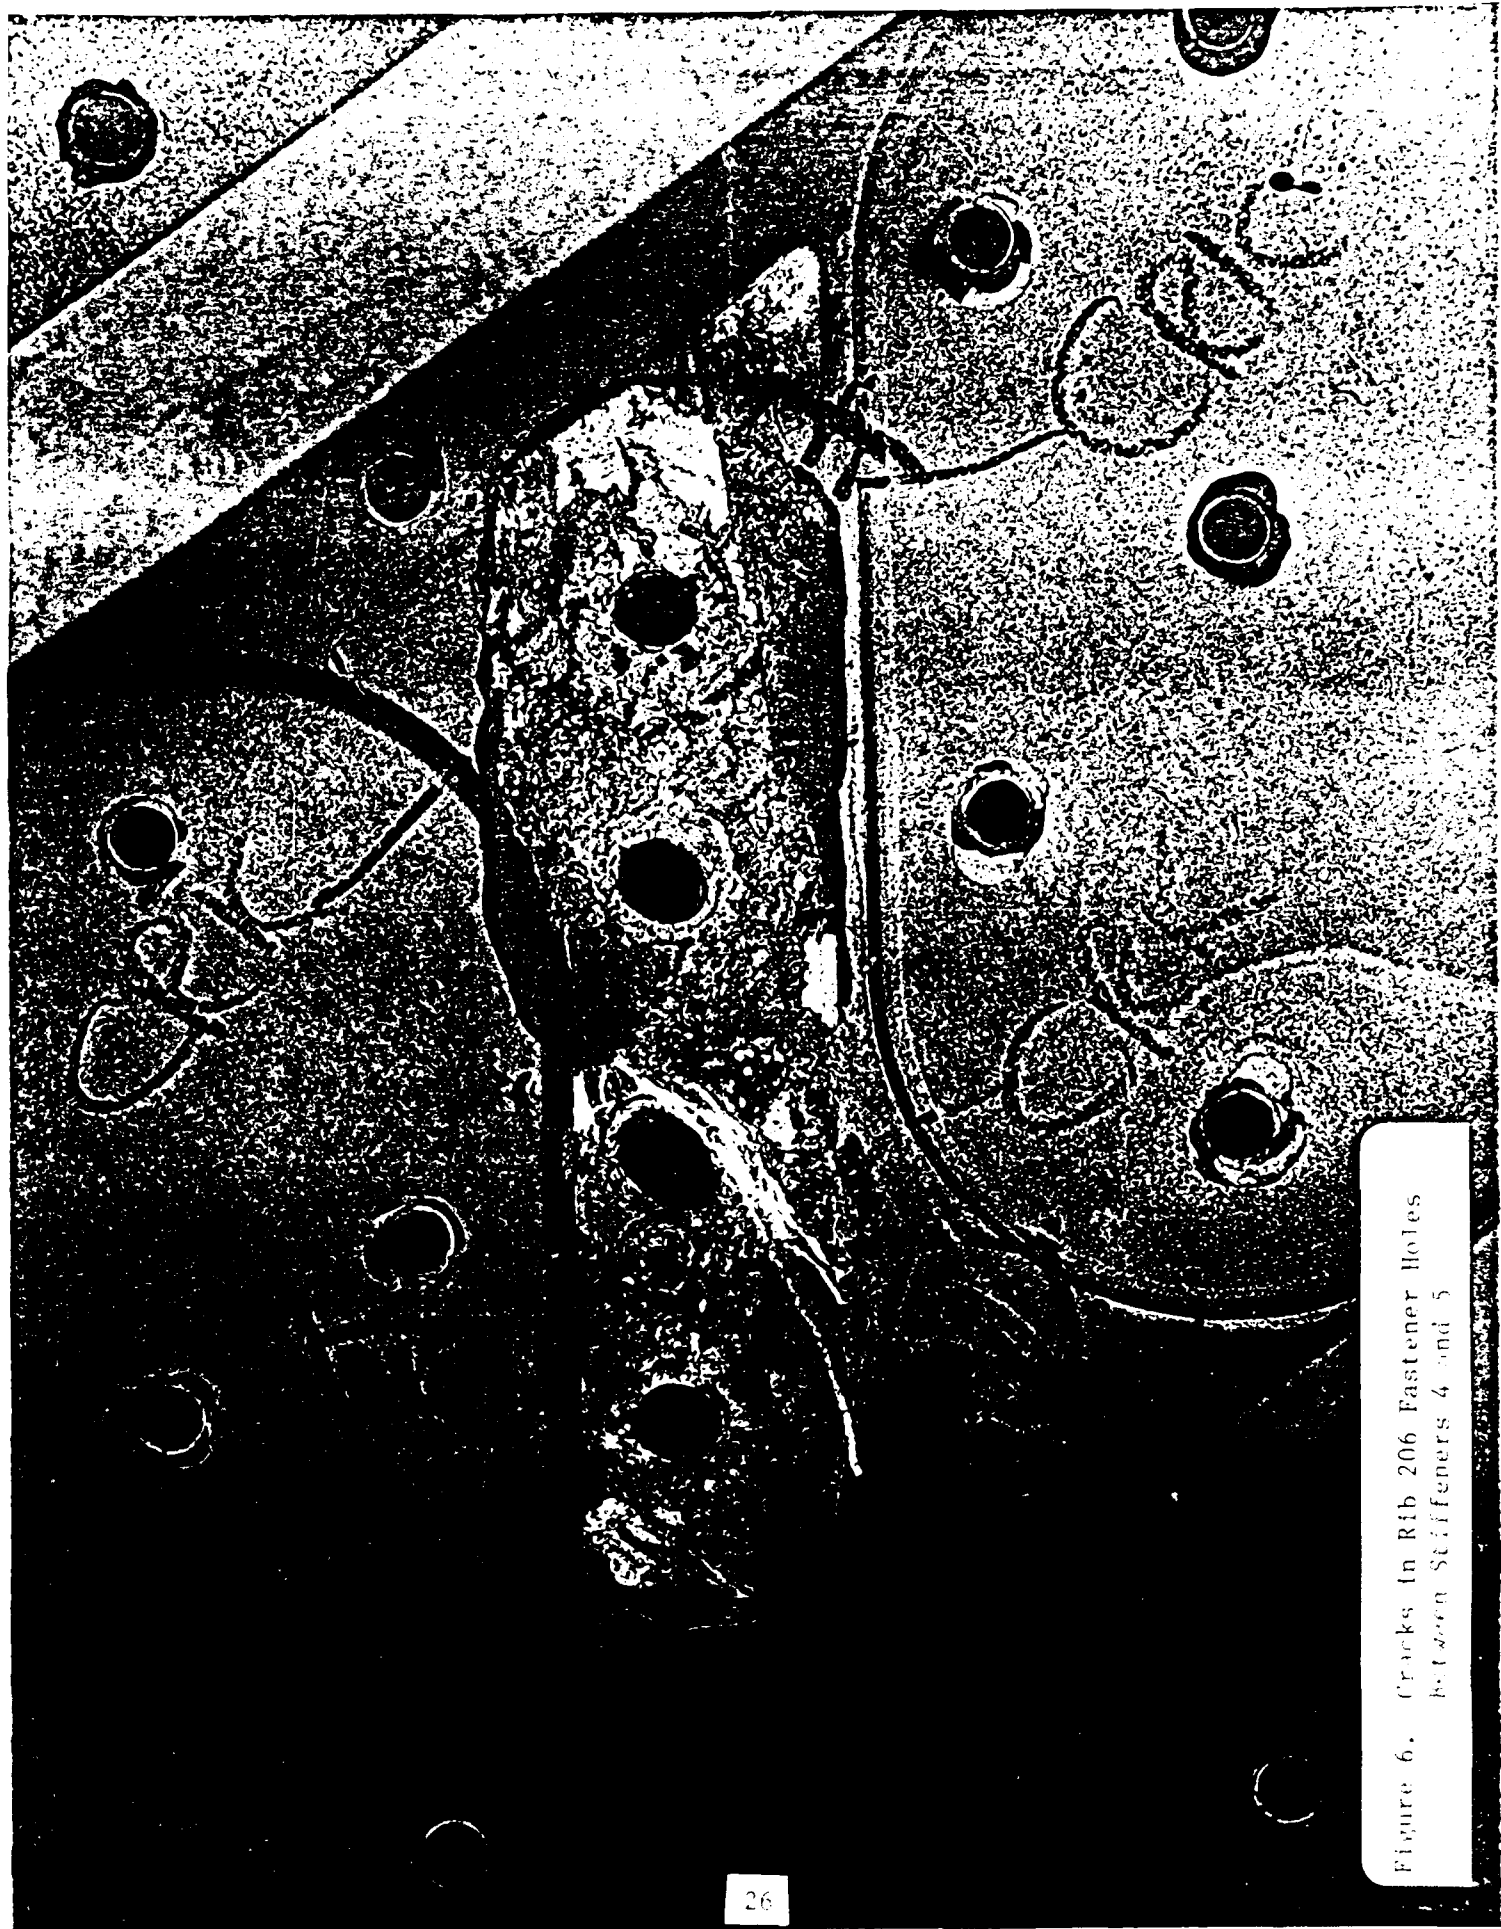
The locations where UOWS fatigue cracks were observed evolved during the course of this investigation. Initially, the concern was for the web of stiffener 4 in bay L1 (see Figure 9) and over rib 206 between bays L1 and L2. Next, it was observed that cracks also occurred over rib 188 between bays L2 and L3. Finally, it was learned that cracks occur over ribs 188 and 206 between the main and rear spars. Ribs 188 and 206 themselves crack, but were not specifically addressed in this study. The numerous access holes in bays L4 and R4 result in a significantly heavier structure and made this area less susceptible to fatigue cracking. Thus, with the exception of bays L4 and R4, high cycle fatigue cracks were observed over the entire UOWS panel.

Figure 6. Cracks In Rib 206 Fastener Holes
Between Stiffeners 4 and 5

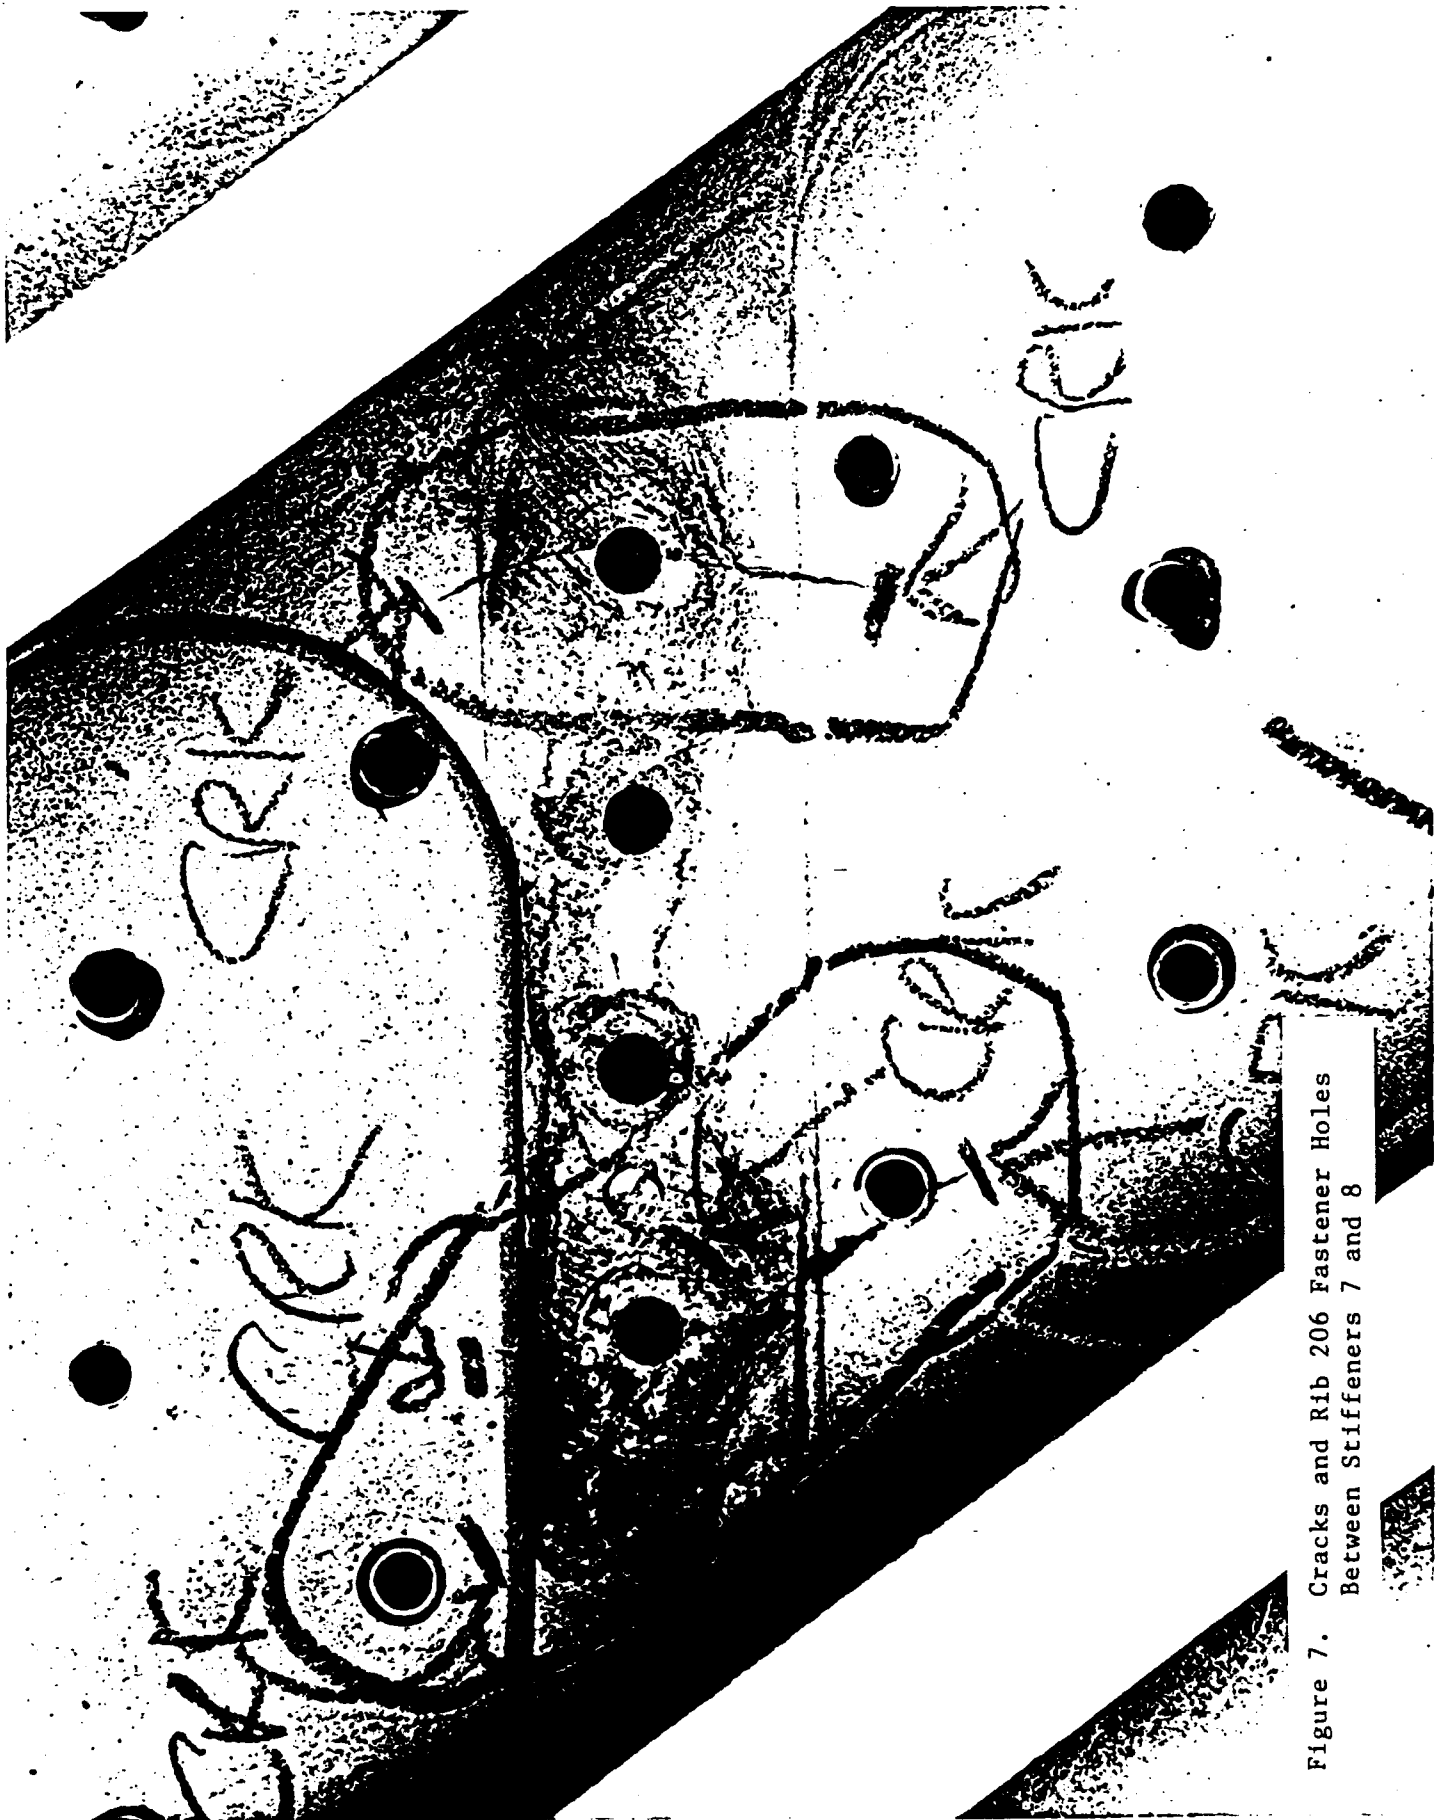
Figure 7. Cracks and Rib 206 Fastener Holes
Between Stiffeners 7 and 8

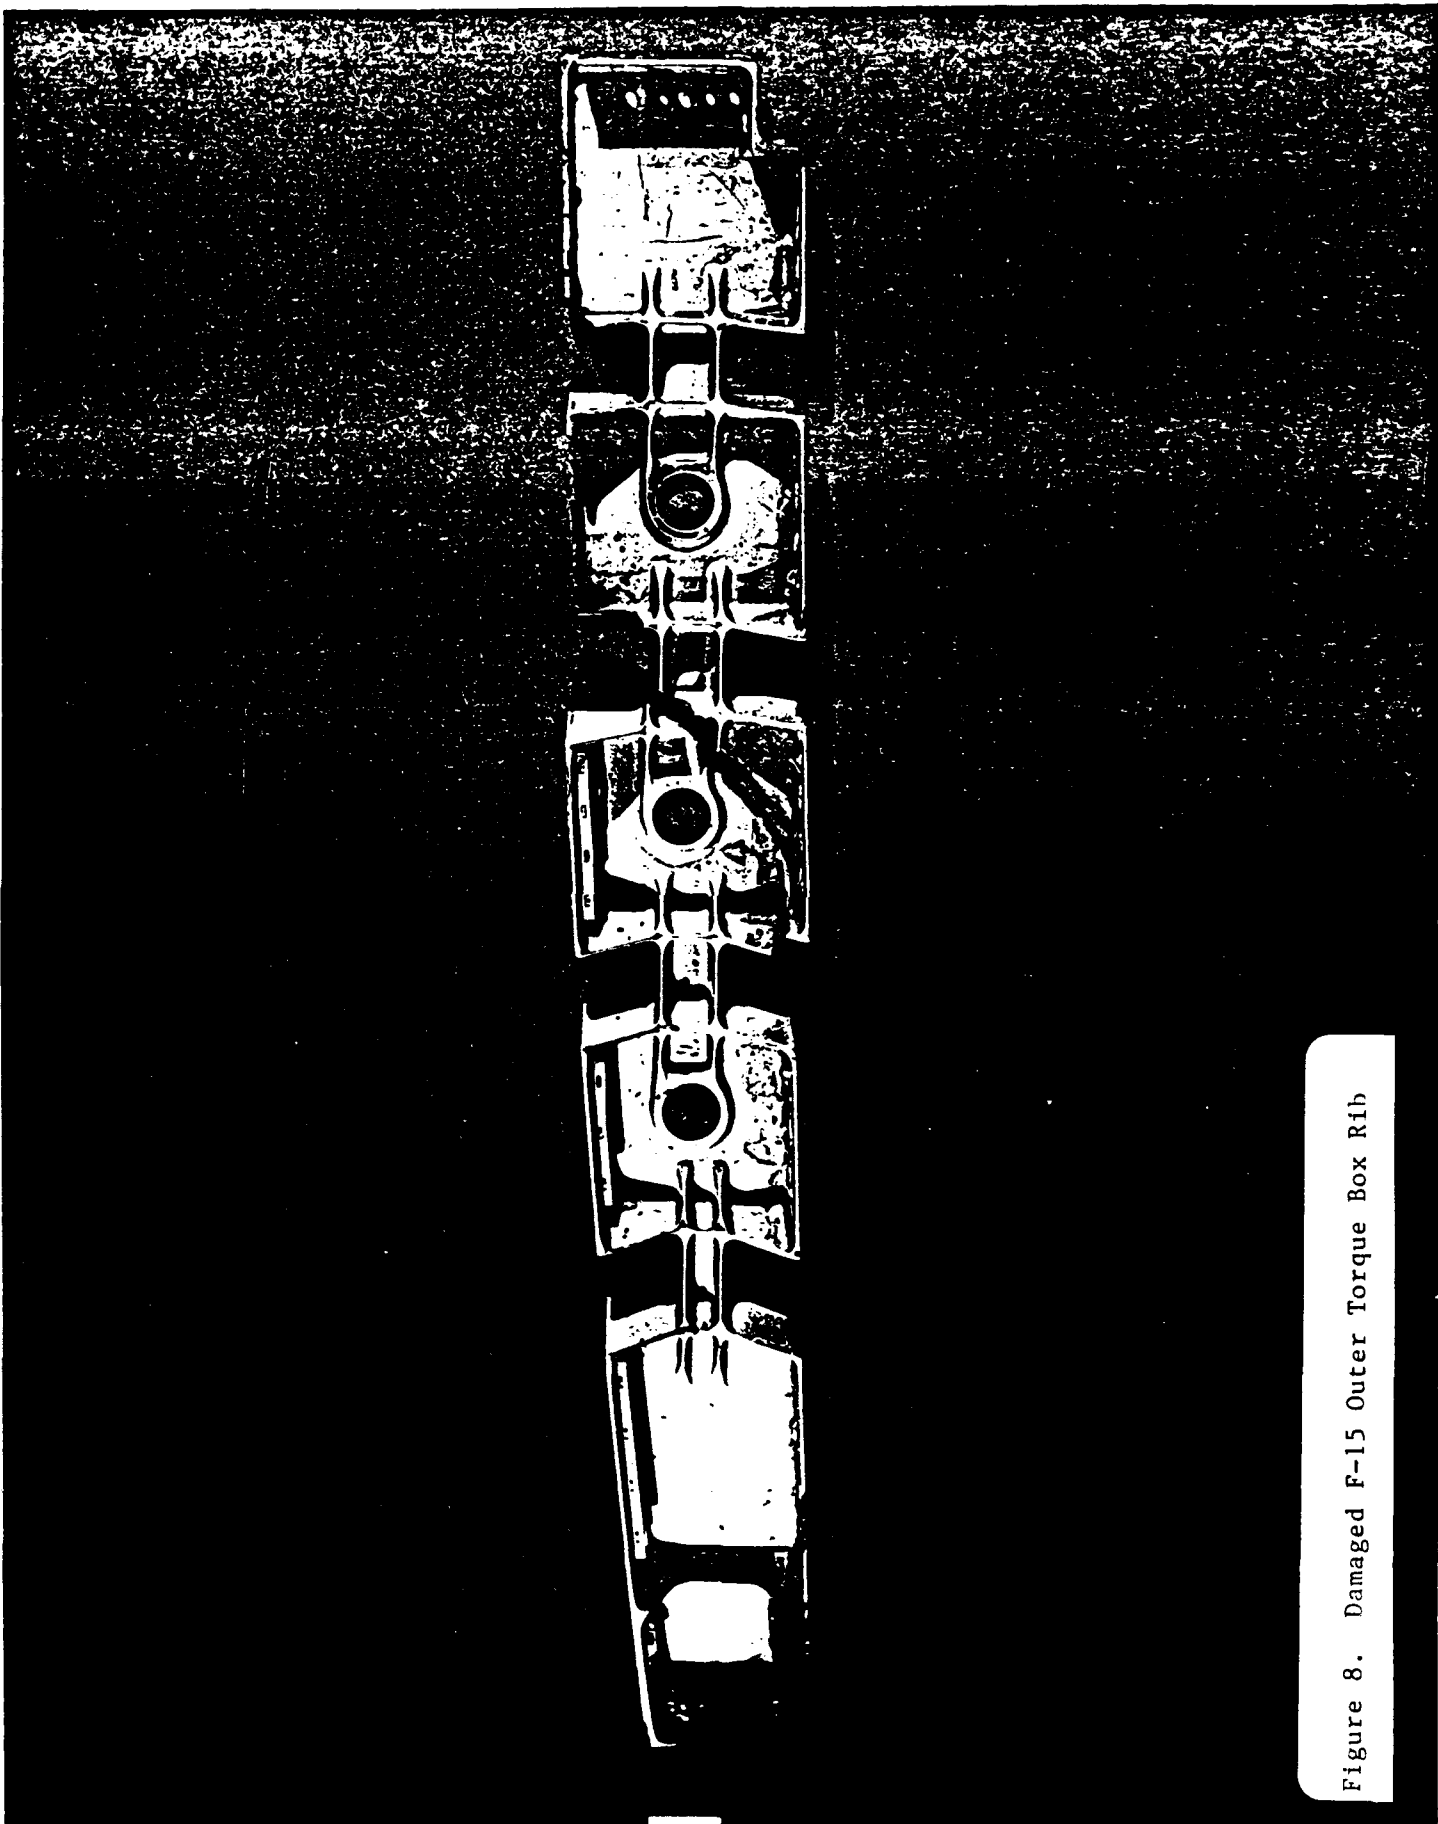
Figure 8. Damaged F-15 Outer Torque Box Rib

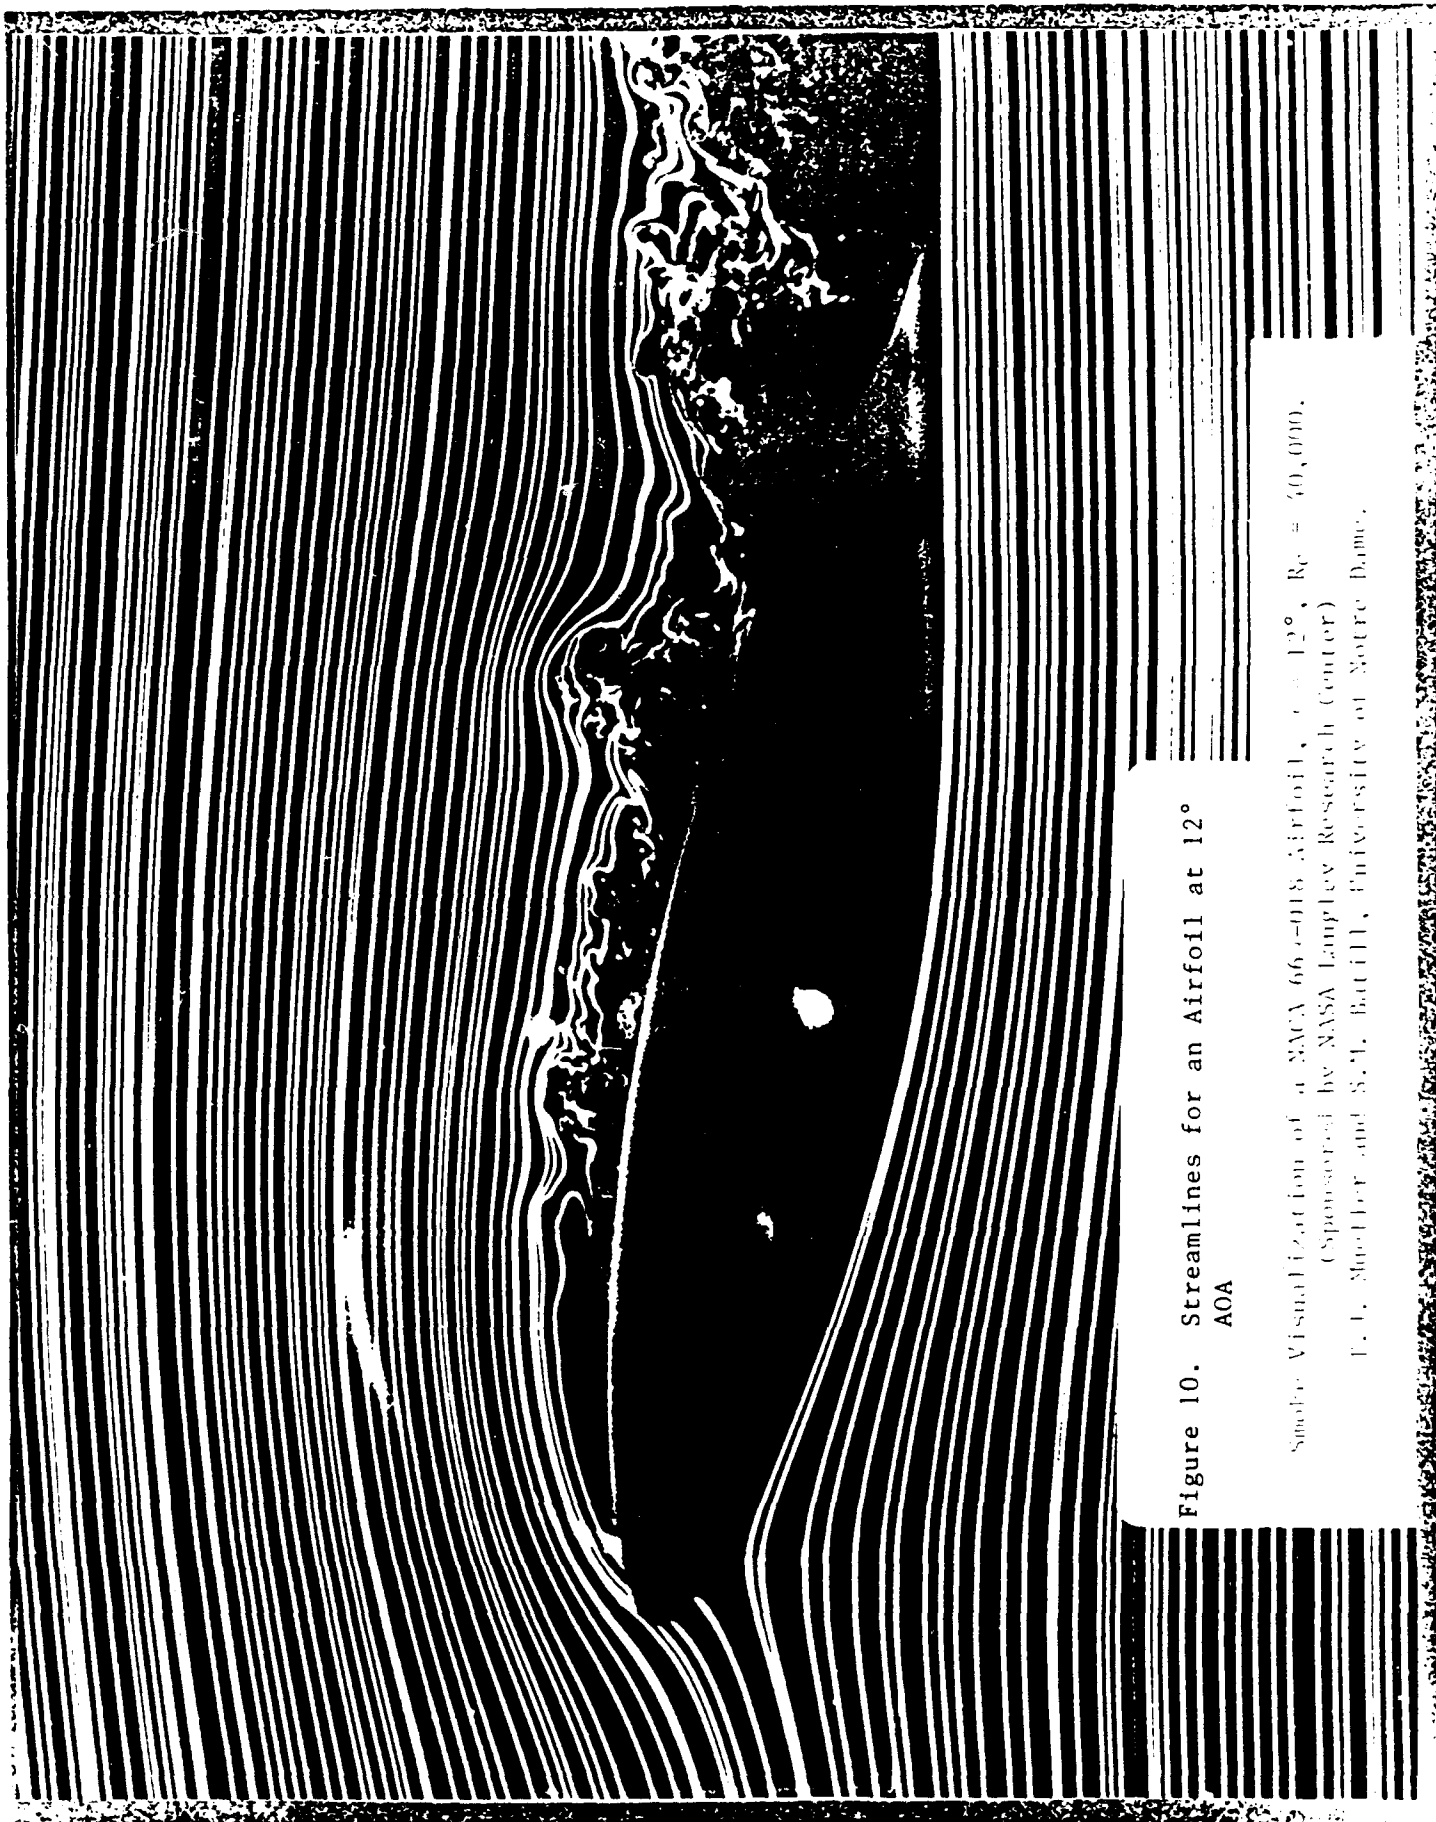
to occur for sufficiently long periods of time to result in damage. Figure 10 is a photo of smoke streamlines for a typical airfoil at 12° angle-of-attack (AOA) and shows separated air flow. Other investigations concerning the aerodynamic characteristics of the F-15 suggest that 12° angle-of-attack provides the most severe disturbances and consequently the most damage.

Figure 10. Streamlines for an Airfoil at 12°
AOA

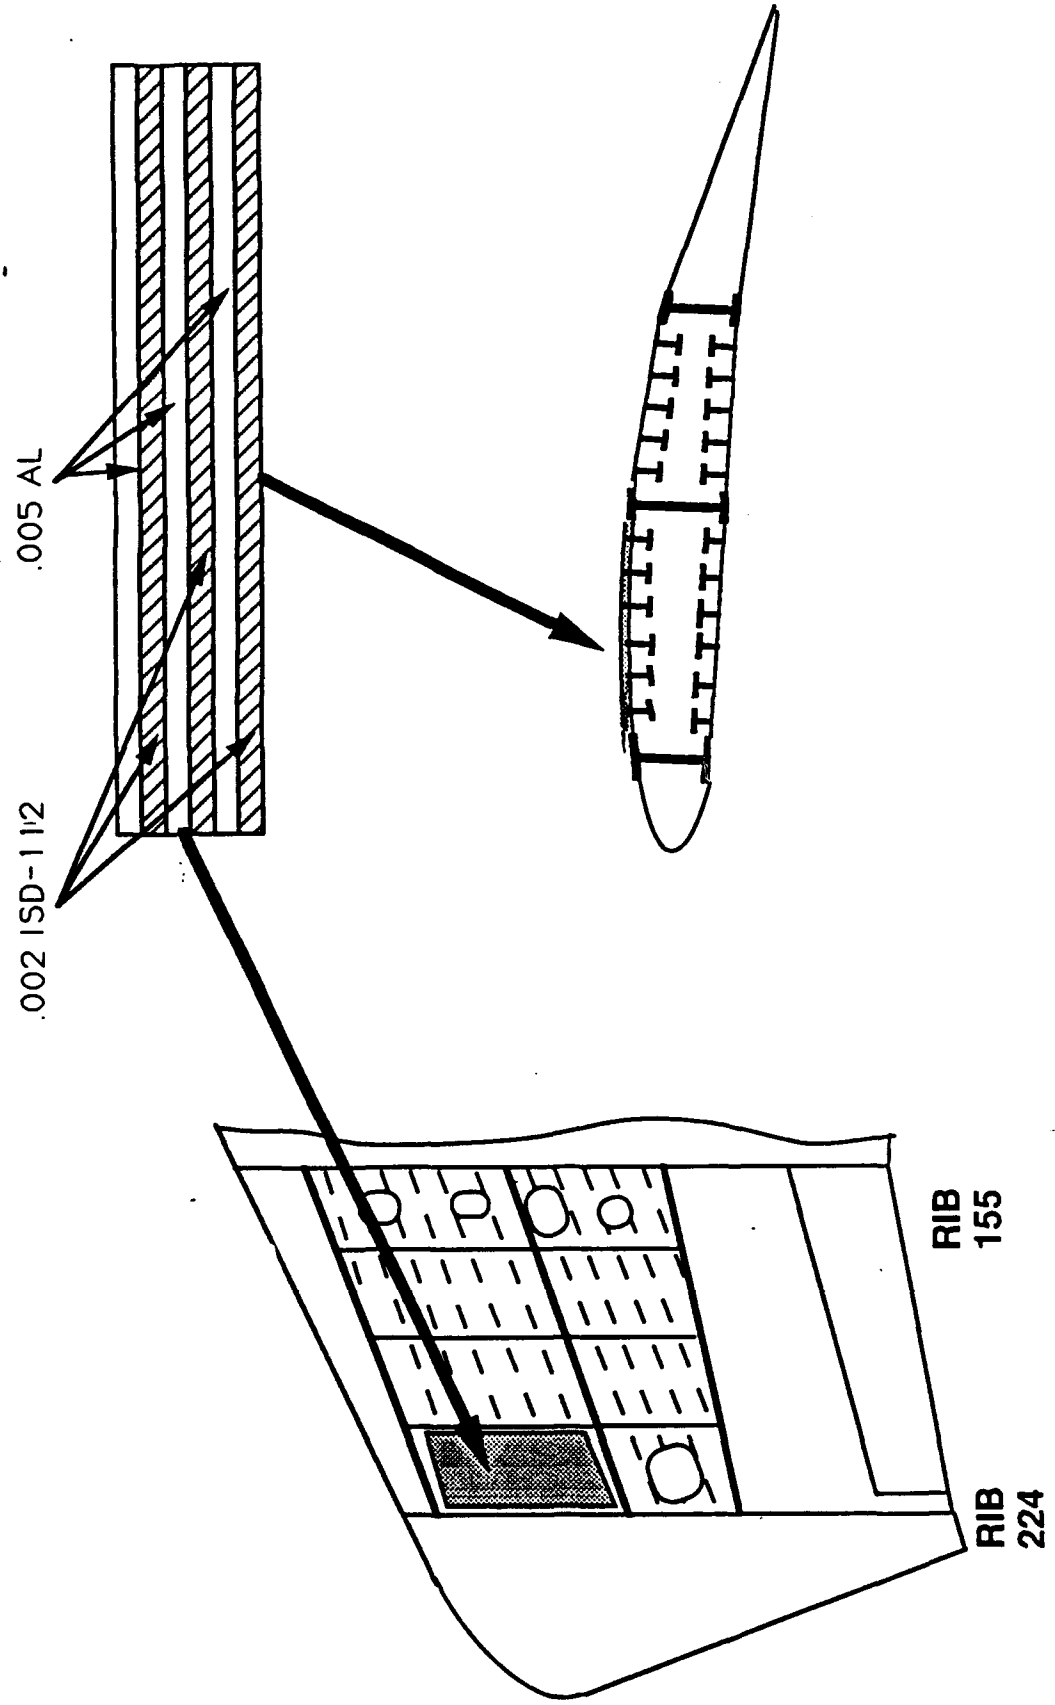
Figure 37. "1980 Damping Treatment"

A previous attempt by MCAIR to correct the UOWS fatigue cracking included the application of a multiple constrained-layer damping treatment referred to as the "1980 Damping Treatment." The treatment was applied externally over bay L1 of the skin (see Figure 9) because at the time, the fatigue cracks were considered to occur

only in this outer spar-rib bay. It consisted of 3 constrained layers, each containing a 0.002" layer of ISD-112 VEM and a 0.005" layer of aluminum. Figure 37 illustrates the "1980 Damping Treatment" which for this investigation was denoted Test Configuration 1 (TC1). Figure 38 is a photo of the "1980 Damping Treatment" installed on an F-15 wing. Note the ramp of sealant around the circumference of the treatment to protect the edge from the air flow and prevent moisture from getting under the treatment. After paint is applied to the top constraining layer and the sealant, the damping treatment is barely noticeable. The "1980 Damping Treatment" was installed and flown on numerous operational F-15 aircraft but it proved to be unsuccessful in eliminating the UOWS fatigue cracks.

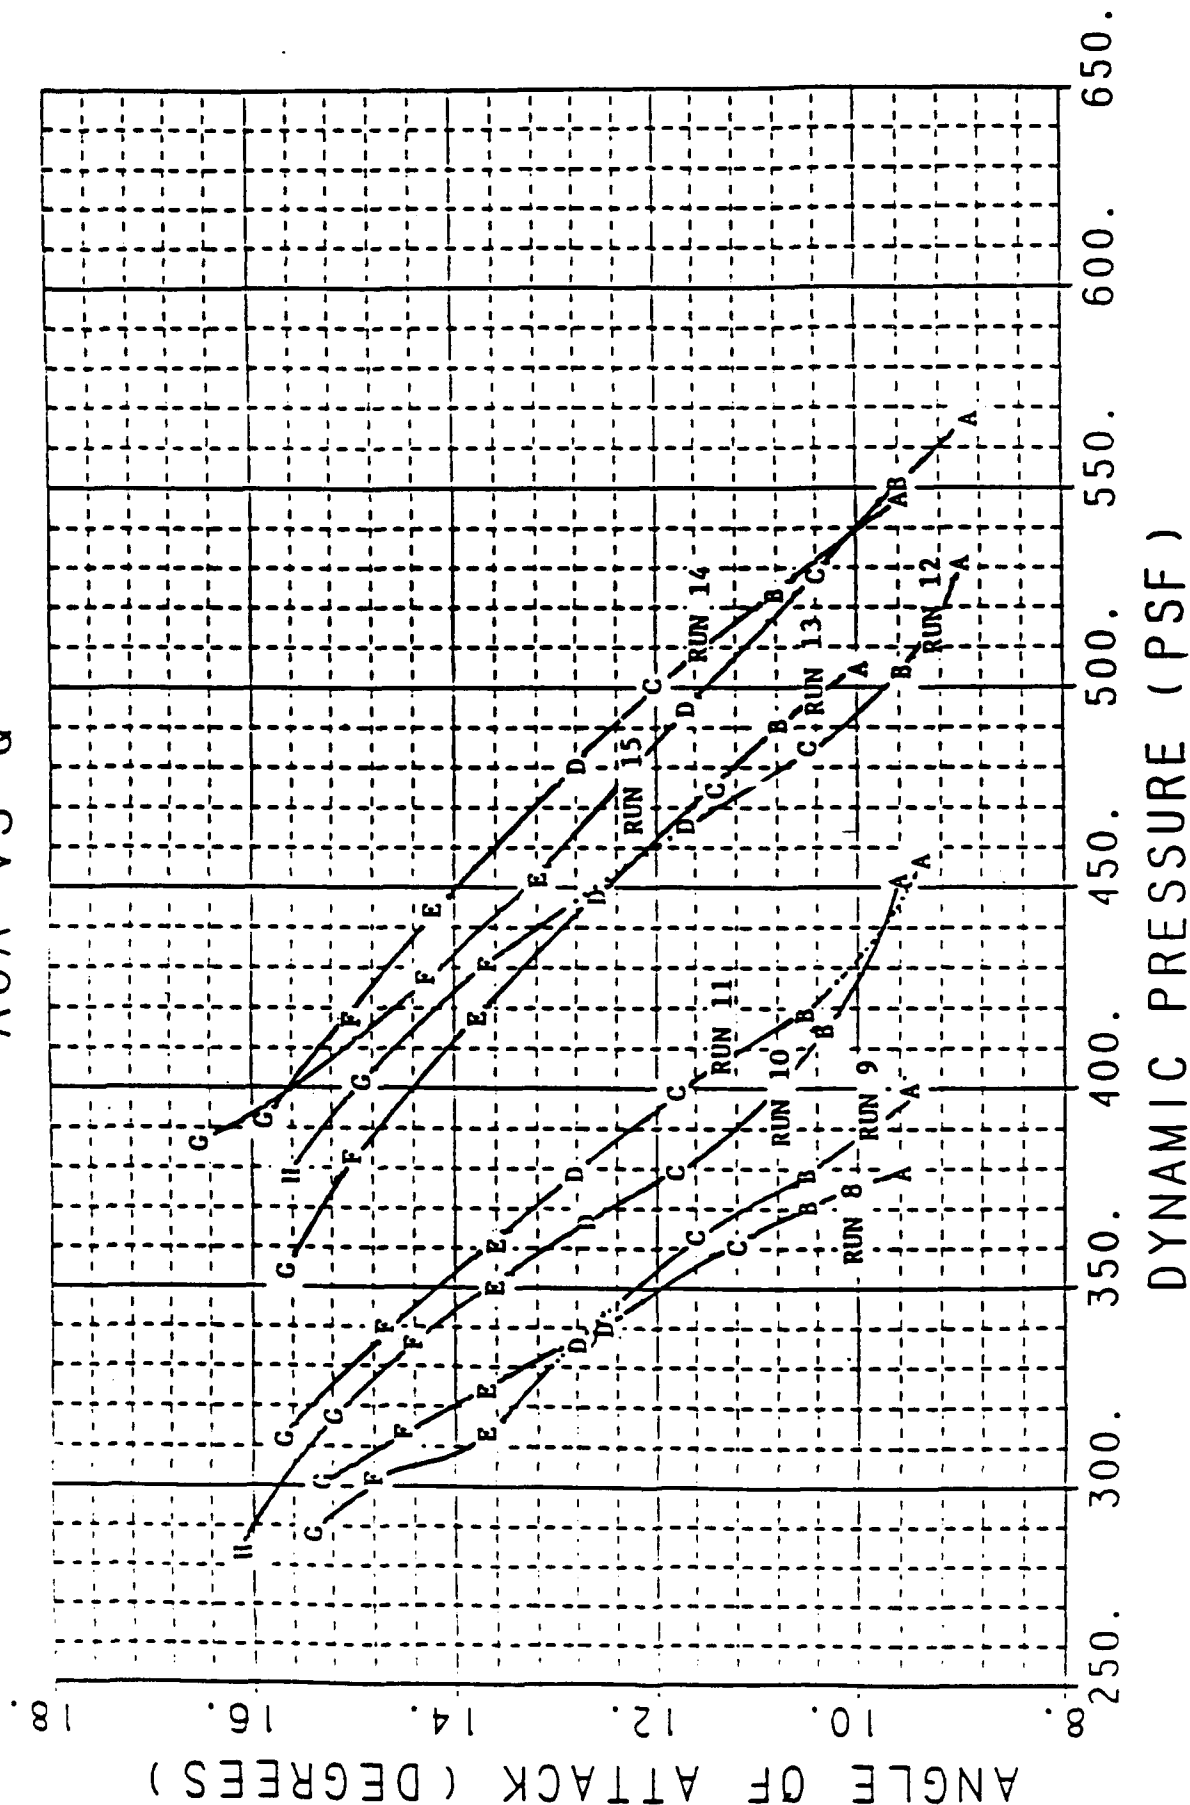
Figure 48. Typical Flight Conditions

A plot of angle-of-attack (AOA) versus dynamic pressure is given in Figure 48 for typical flight conditions for which high load factor maneuver data was gathered. The range of dynamic pressure, q of 350 psf to 500 psf, for the 12° AOA shown in this plot illustrates the difficulty, if not impossibility, of duplicating the service conditions for which damage is induced. The power spectral density (PSD), shown in Figure 49, was typical of the UOWS response at the strain gage locations shown in
